Manhole Inspection Summary

Manhole # S11WW1003MH

Insp Date: **7/24/06 1:39 PM**

Location Address: **2409 KEN OAK RD**

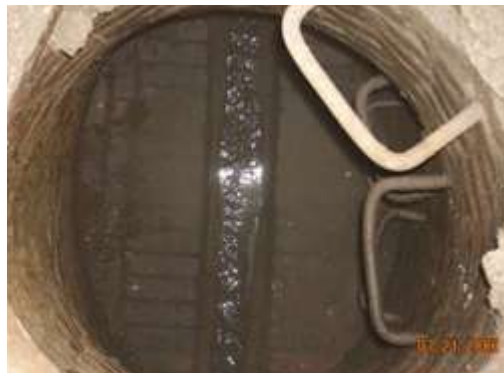
Top View

Evidence of surcharge - Bench debris.

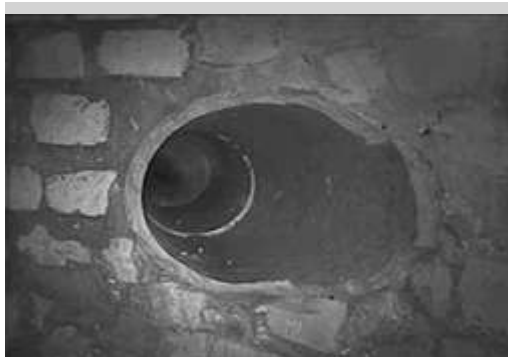
Comments **Storm sewer that runs parallel to this line is in this MH. There are remains of the pipes in the manhole. In the other manholes the pipe is solid next to and above the channel. In this one there is an inlet and an outlet in the corresponding.**

Storm sewer that runs parallel to the sewer line.

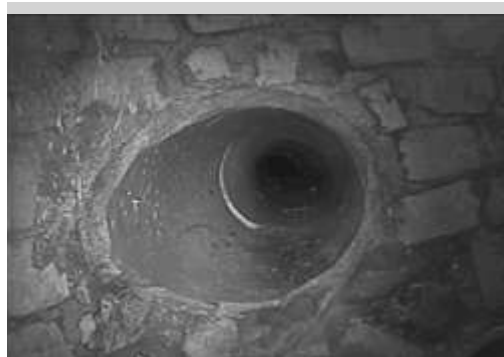
Storm sewer that runs parallel to the sewer line.

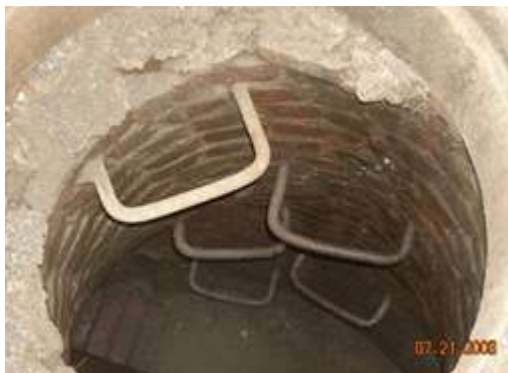
Defect

Frame leaks. Frame offset. Adjustment deterioration, loose brick and infiltration. Corbel and Barrel infiltration - other side.

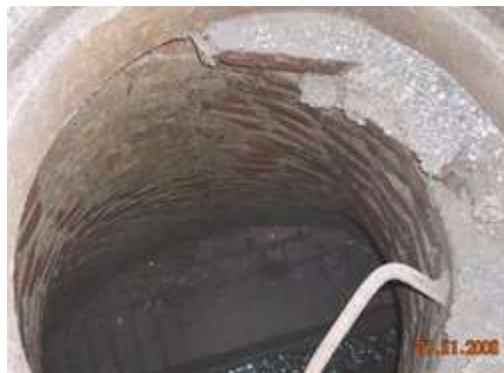
Defect

Frame leaks. Frame offset. Adjustment deterioration, loose brick and infiltration. Corbel and Barrel infiltration.

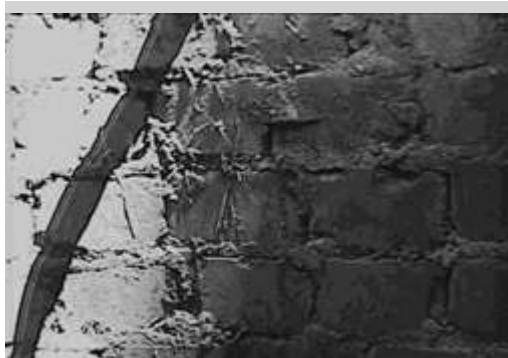
Defect

Corbel root intrusion, deterioration and infiltration.

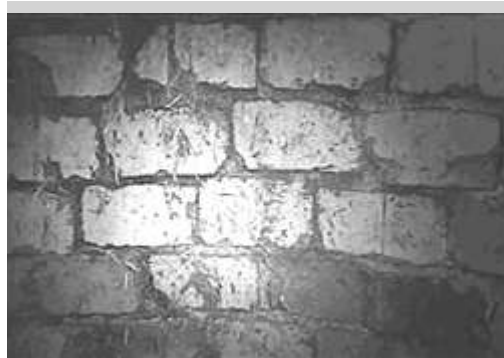
Defect

Barrel root intrusion and infiltration.

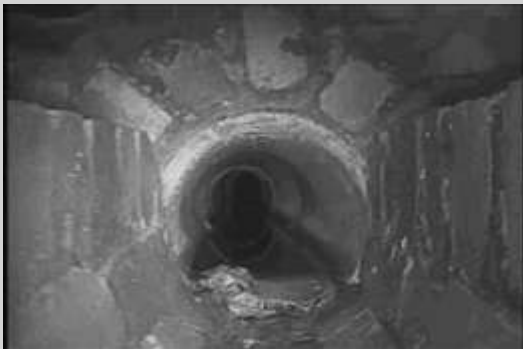
8 in. Circular Gravity Sewer Pipe In @ 6 O'Clock

Deposits: ☐ None ☒ **Mud** ☐ Sludge ☒ **Debris** ☐ Grease

Silt Depth: **0.5** (in.) Deposits Extent: **Light**

Infiltration: **Evidence** Pipe Seal Cond: **Unknown**
